COMPARISON OF THE RELEASE OF LARGE-SCALE COMPONENTS AND FRAGMENTS OF AUXILIARY EQUIPMENT OF V1 NPP

Matej Forgáč

DRO 2021

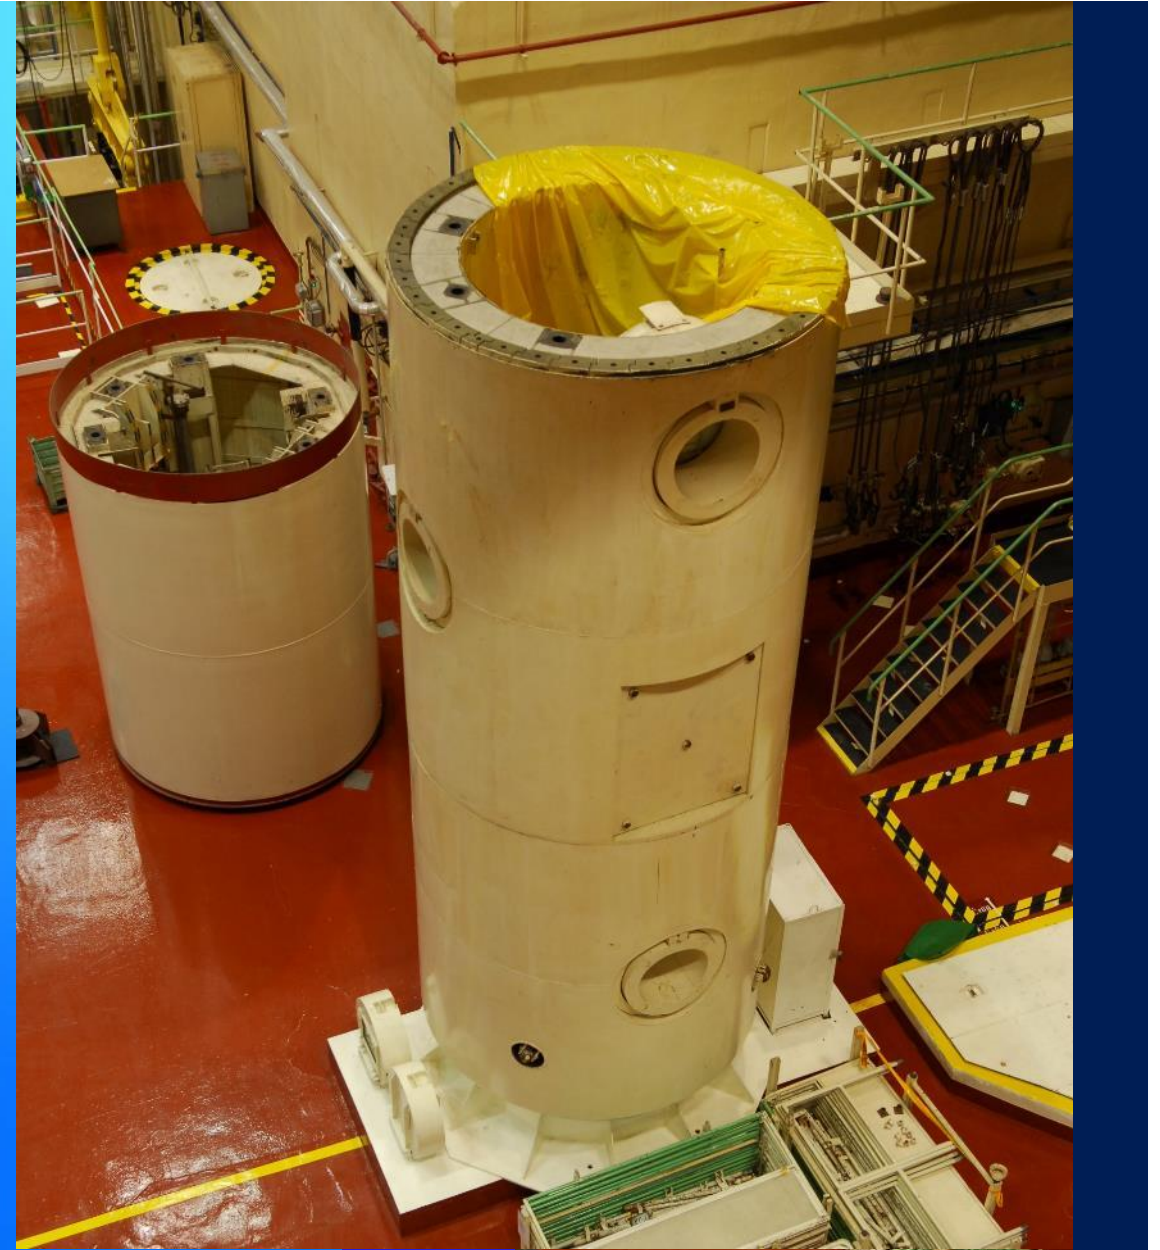
- low usability in operation
- pressure vessel inspections
- 3 segments (bottom, middle, upper)
- 3 materials (concrete, lead, steel)
- + Concrete container stand
- + Transportation traverse

- Decommissioning database vs. Technical documentation
- 62110 kg vs. 175645 kg
- explore all options to make the process of dismantling Concrete container more effective in order to minimize the increase in material production (both primary and secondary)
- Middle and bottom segments were not used during operation
- Upper segment was used for sampling of Reactor pressure vessel

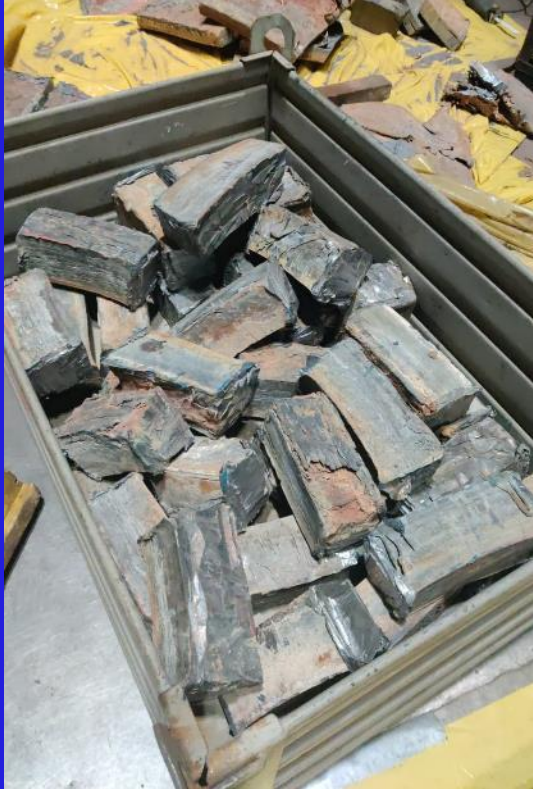
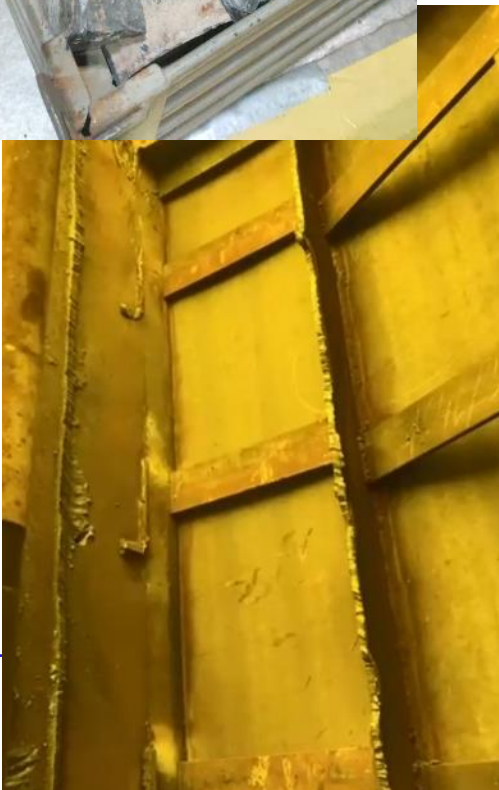
Bottom and middle segment

Data of free-released middle and bottom segment with dismantled internal structures.

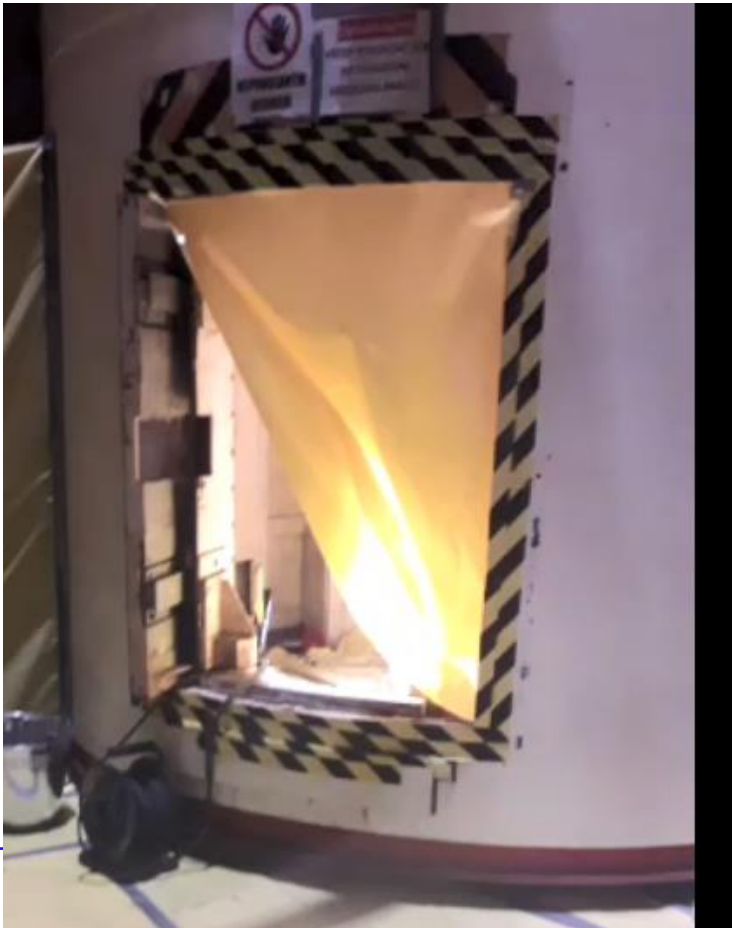
The consignment did not meet the release conditions - the surface contamination was higher than $0,4 \text{ Bq/cm}^2$: from $3 - 10 \text{ Bq/cm}^2$.

The bottom section of the segment (up to a height of approximately 1 m) should be cut off.

During
fragmentation
within
Controlled area

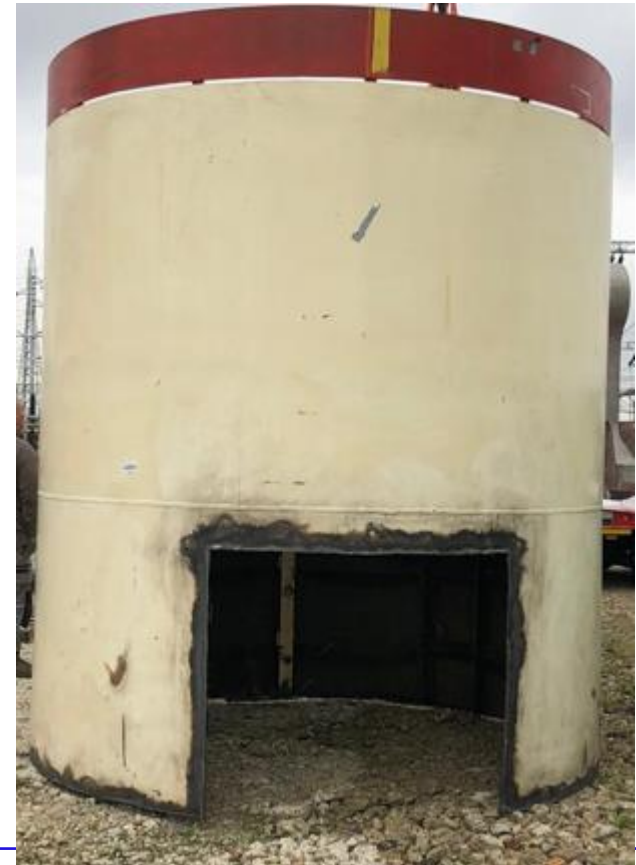
After
fragmentation
outside
Controlled area

The estimated amount of separated section is approximately 3100 kg. Section contained lead (approximately 4000 kg).
